Between November 2021 and July 2022, SafeWork SA undertook a compliance campaign titled "Nature Play and Playground Proactive Compliance Campaign" (the campaign).

Nature Play and Playgrounds SAFETY COMPLIANCE INSPECTION - 2021 Site Inspection Report

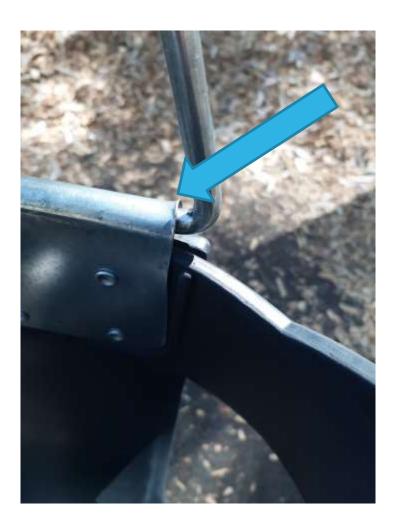
Toddler Swing – Sharp Edges

- Maintenance and inspection of plant condition of a mud kitchen presenting a structural risk.
- Provide and maintain safe plant/structures connection points on a bent swing and having sharp edges presenting a laceration risk.

This photo show the connection points on the swing are bent with sharp edges presenting a laceration risk.

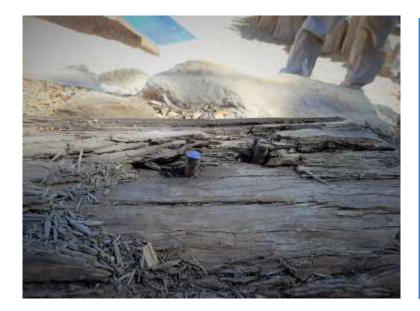
Rebar Hazard

The rebar was exposed above the log level causing trips/falls, and impalement risk for patrons.

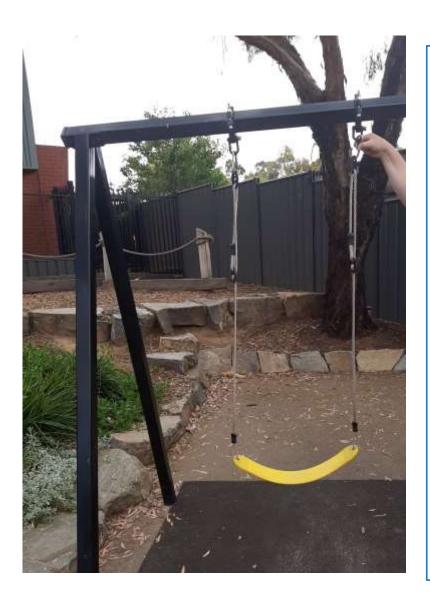
Rope Swing

This photo shows the hazards inherent with this style of rope swing where the rope adjustment was doubled over within a child's reach, presenting a risk of finger or limb entrapment.

The carabiners securing each rope in place were non locking and could easily be opened without a tool or key.

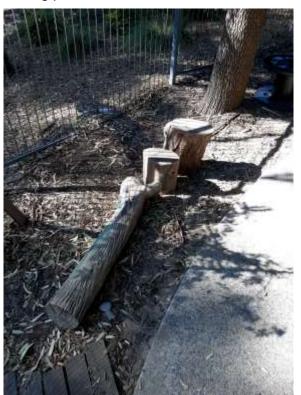
Loose Logs

This photo shows a section of a playground with loose logs. This causes a risk of children running across them believing them to be stable and then falling and causing injury.

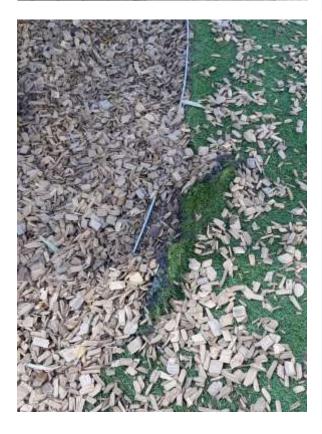
Tripping hazard

This photo shows lifted artificial grass which is causing a tripping hazard.

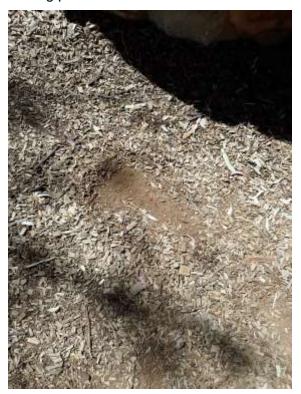
Lack of fill

This photo shows missing loose fill in the playground area exposing the playground edge.

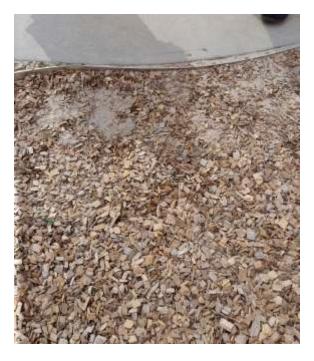
Compacted fill

This photo shows how fill has become compacted over time such that it is no longer loose fill. The following 2 photos show the fill at the time of the notice being issued and then after compliance was achieved.

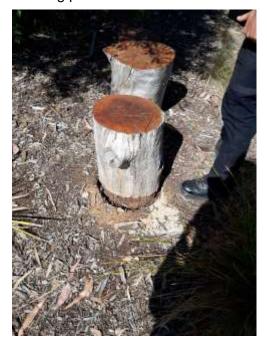
Stepping Log

These tree stumps were installed in a singular line with graduating heights for climbing/walking on in the nature play environment.

Initially the log was installed using cement, as per design. The log was found to have significant movement when stepped on, and not secured in place.

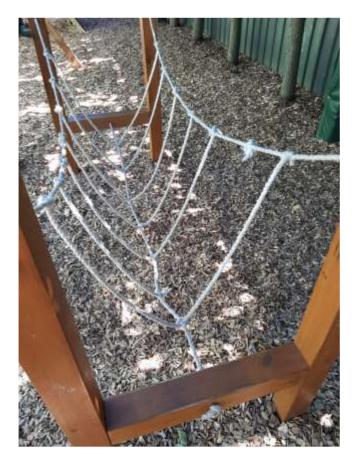
Rope Bridge

The rope bridge located in the playground had a missing support rope and was noticeably frayed.

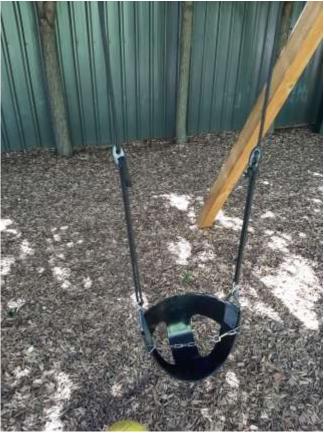
Swing

The swing located in the playground had a black rope connecting the seat to the frame with metal carabineers. The rope was doubled over (using black plastic loops) and presented a risk of finger entrapment for the user.
